**Re: Bill Jerome Arena Structural Assessment Report  
AE2S P15575-2023-001**

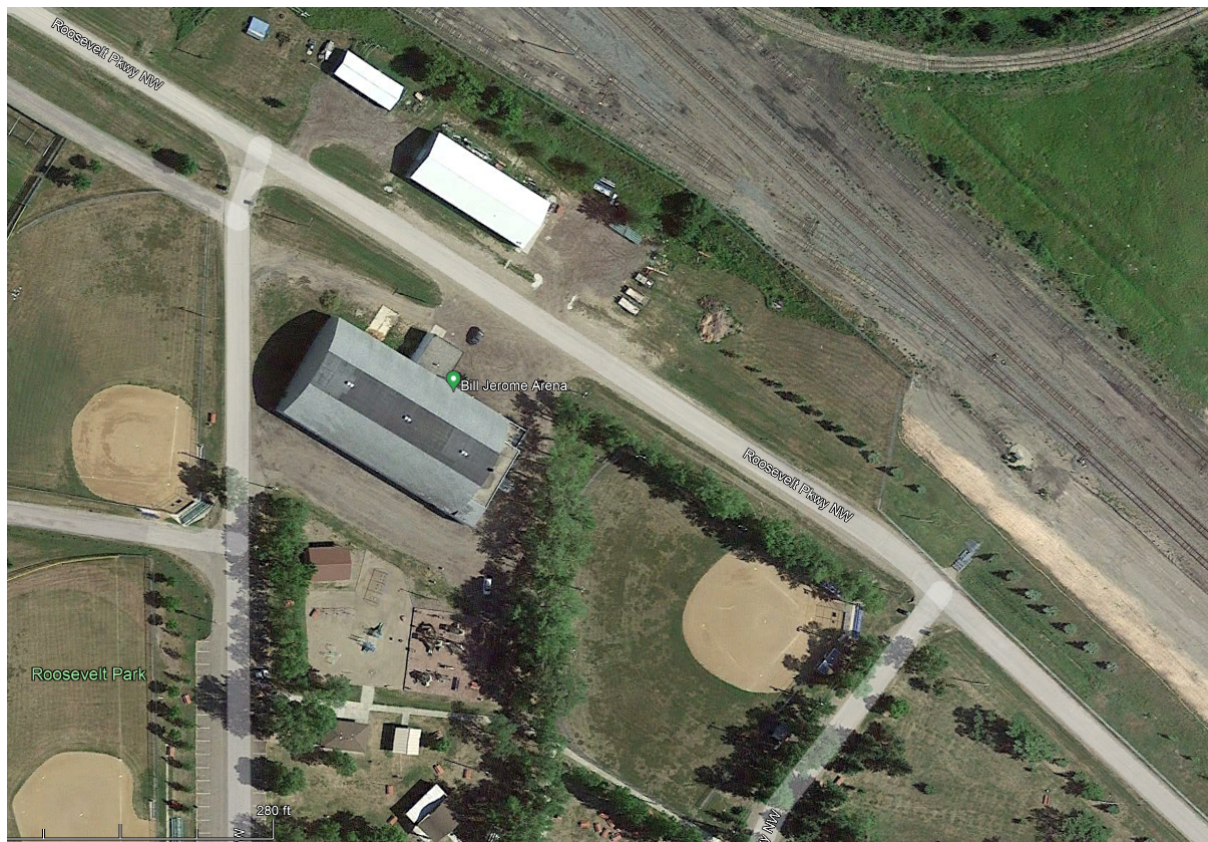
The axis of the facility runs NW/SE but for purposes of discussion the main lobby is the east end and the resurfacers room is on the north side.

The structure is highlighted by the circular arch roof system over the main arena portion:

- Wood chord arches spaced at 20'-0" with steel rod vertical webs and wood compression webs (P001 - P009).
- Variable depth arches, approximately 6'-0" deep at the crown and 5'-7" deep at the base.
- The arches directly support solid sawn roof joists spaced approximately 24" on-center, spanning east-west (P001, P008, P009).
- The roof deck is diagonally laid solid sawn wood board, supported by the roof joists (P019).
- The chords are multi-ply wood assemblies of variable thickness (P009, P021).
- The bases of all arches are supported by cast concrete piers (P021).
